NEW IMAGES OF THE ERECHTHEION BY EUROPEAN TRAVELLERS

ALEXANDRA LESK, UNIVERSITY OF CINCINNATI

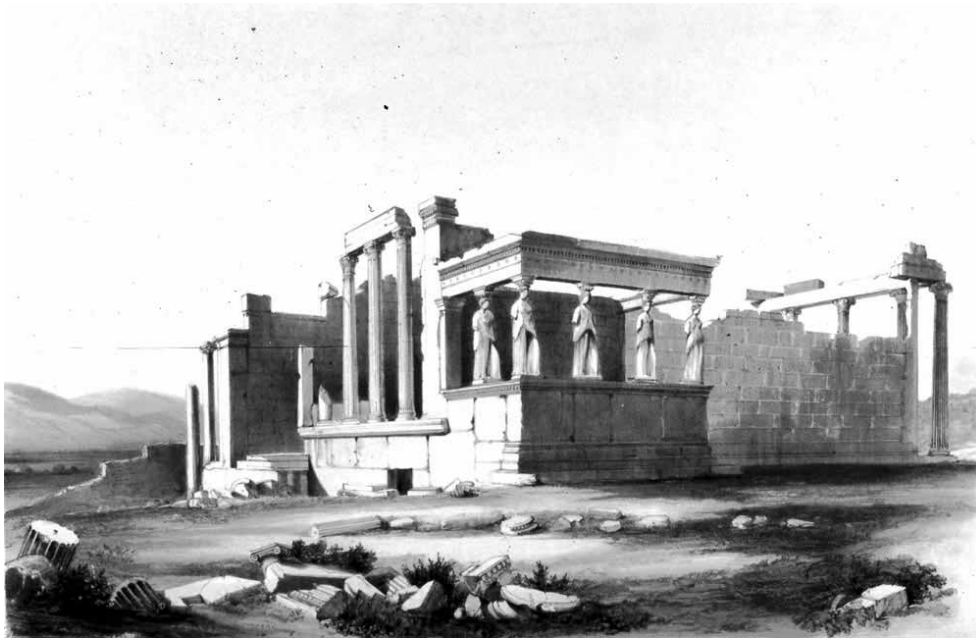
Figure 13: H. Cook (1819-1980), *The Erechtheion*. 1846. By courtesy of the Museum of the City of Athens.

Figure 14: E. H. Martineau, *Athens, Acropolis, The Erechtheum*. 1850. By Courtesy of RIBA Library Drawings Collection.

The Maiden Porch soon received further attention from the French architect Alexis Paccard who repaired the porch between 1846 and 1847 (Guillaume 1870). Two new depictions, by Cook and Martineau, show the Maiden Porch immediately after its restoration in 1850 (Figure 13Figure 14). Maidens #1 through #5 are in place, but the roof is still missing. “Opus Elgin” has been replaced by a terracotta cast. In other renditions of the South Porch after this time, artists actually represent the difference in colour of the Elgin replacement (Werner 1877). Maiden #4 received a replacement capital, and the architraves, podium and crepidoma were repaired with new blocks and replaced. Italian sculptor Andreoli restored the missing parts of Maiden #6.
